Hybrid Eurasian water-milfoil (*Myriophyllum spicatum* X *sibiricum*)

Fall Bed Mapping Survey

Namekagon Lake - WBIC: 2732600 - Bayfield County, Wisconsin

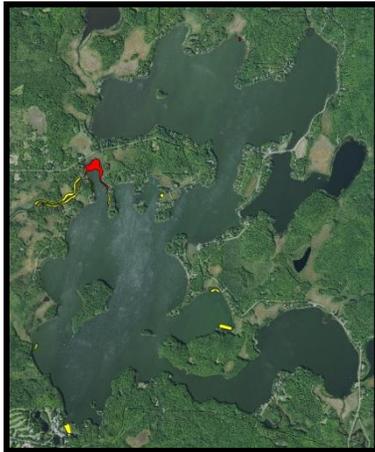
HWM Beds (Red) and HDAs (Yellow) Fall '18

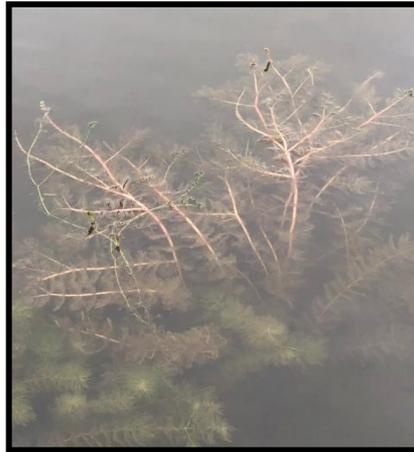
Canopied HWM Cluster in Upper Lake (Berg 2018)

Bed 12 – We found this tiny canopied bed already had many well-established multi-stemmed plants that were merging into a solid mat at its core (see front cover). Many were prop-clipped, and we saw several floating fragments throughout the area near Mogasheen Resort (Figure 7) (Appendix I).

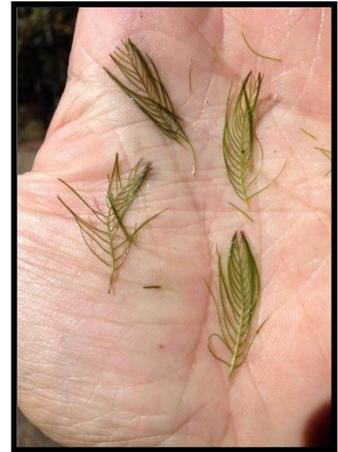
HWM with 24-30 Leaflets (Berg 2016)

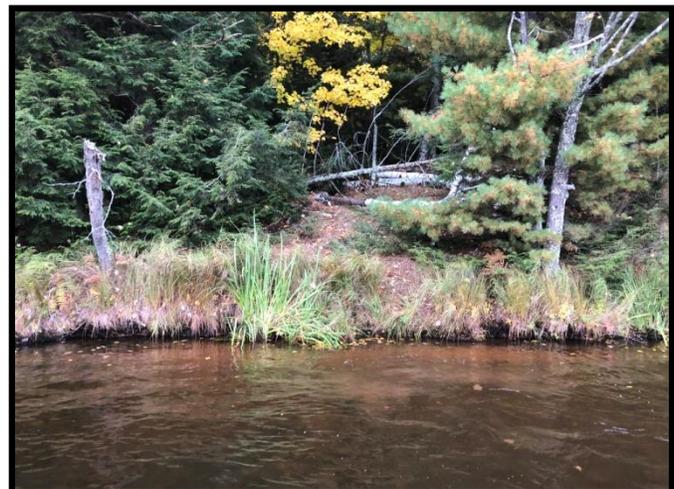
Yellow Iris Cluster along the Namekagon Lake Shoreline (10/7/18)

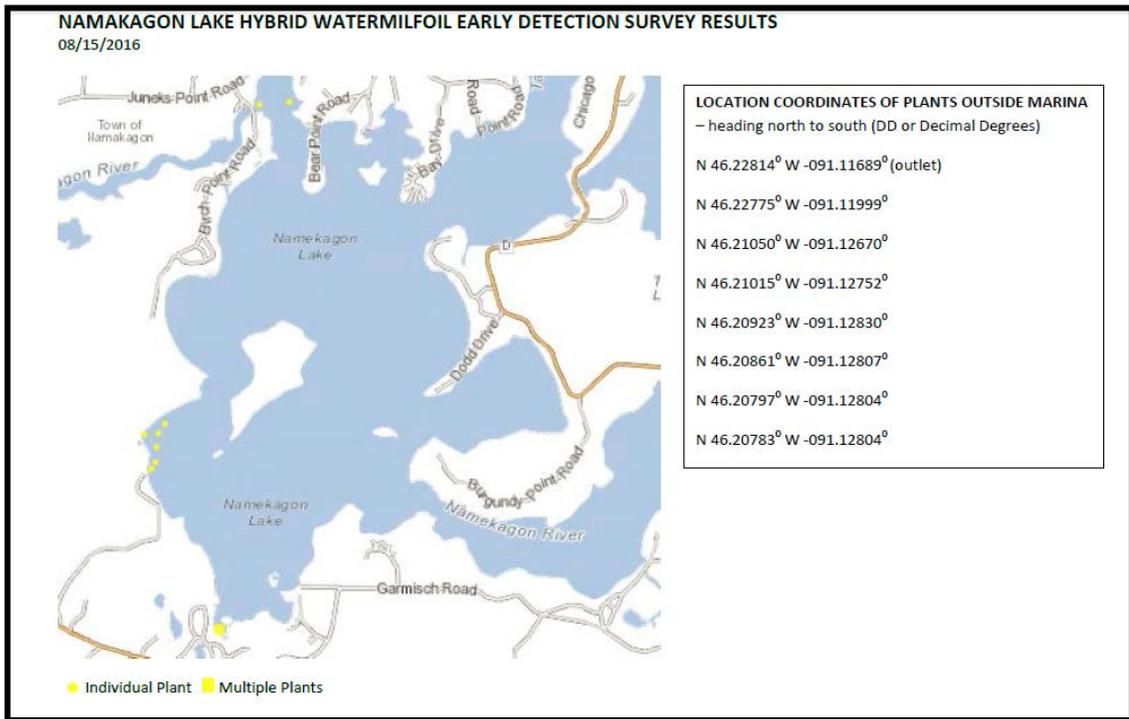
Figure 2: HWM Locations – Early Detection Survey - 8/15/16

On August 15th, a team of professionals from the WDNR and BCLWCD conducted a shoreline survey of the lake. They found and rake removed a few scattered plants in the bay immediately northwest of the Lakewoods Resort Marina Landing/southwest of Paine’s Island as well as two additional plants in the bay near the river outlet (Figure 2). This survey was followed by hand removal efforts coordinated and overseen by the WDNR (Pamela Toshner – Regional Lake Biologist), BCLWCD (Andrew Teal – Bayfield County Aquatic Invasive Species Coordinator), and the University of Wisconsin Extension (Paul Skawinski - Citizen Lake Monitoring Network) on both August 15th and 23rd. On these dates, volunteers from the Namekagon Lake Association (NLA) and employees from the Lakewoods Resort joined the professionals in rake removing dozens of HWM plants from the marina area.

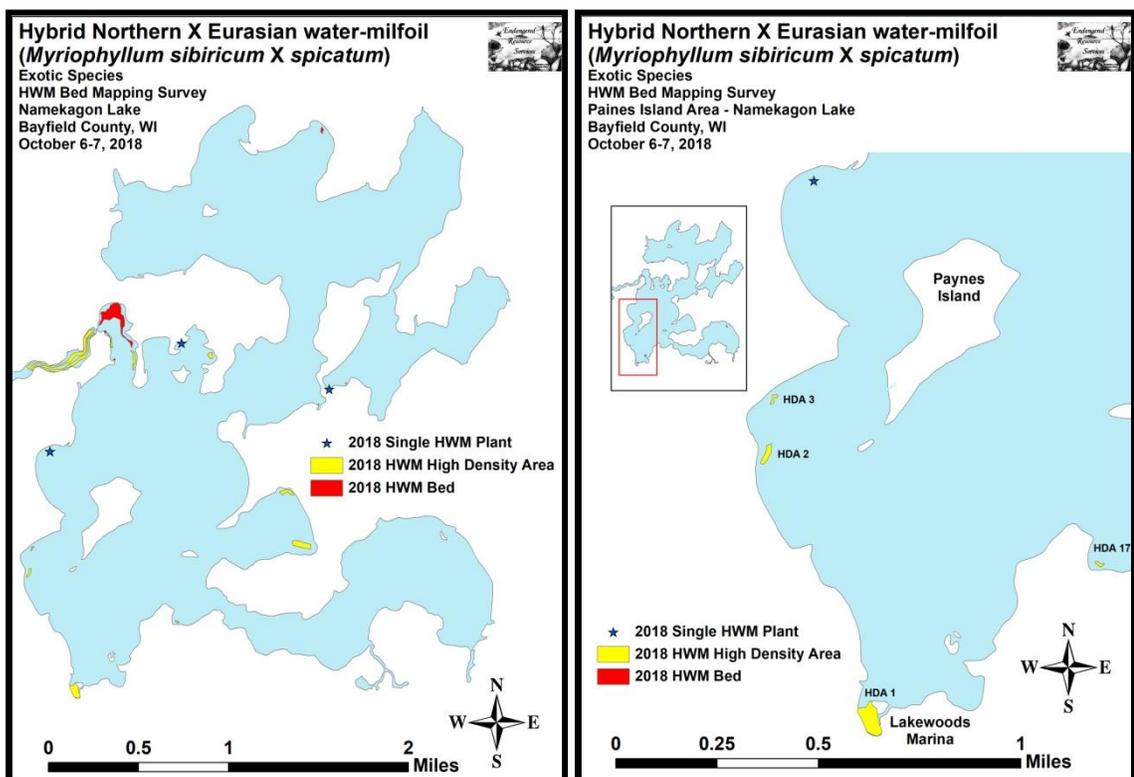
Figure 5: 2018 Fall HWM Bed Map/HDAs 1-3 and 17 – Southwest Bays

HDA 1 – Hybrid water-milfoil continued to be scattered around the Lakewoods Marina, although no true beds existed suggesting past treatments and manual removal have been successful in keeping it in check. In total, we marked and rake removed just ten plants from this area (Figure 5) (Appendix I).

HDAs 2 and 3, and the West-central shoreline – We found and rake removed six and eight plants respectively from these HDAs. This was an unexpectedly low total as we also found scattered plants in these areas during the summer of 2016 (Perhaps volunteers have worked this area as well as near Lakewoods?). Equally surprising, we only found one additional plant in the bay directly west of Paine’s Island. Apparently prevailing currents are carrying fragments to the outlet rather than depositing them in this area.

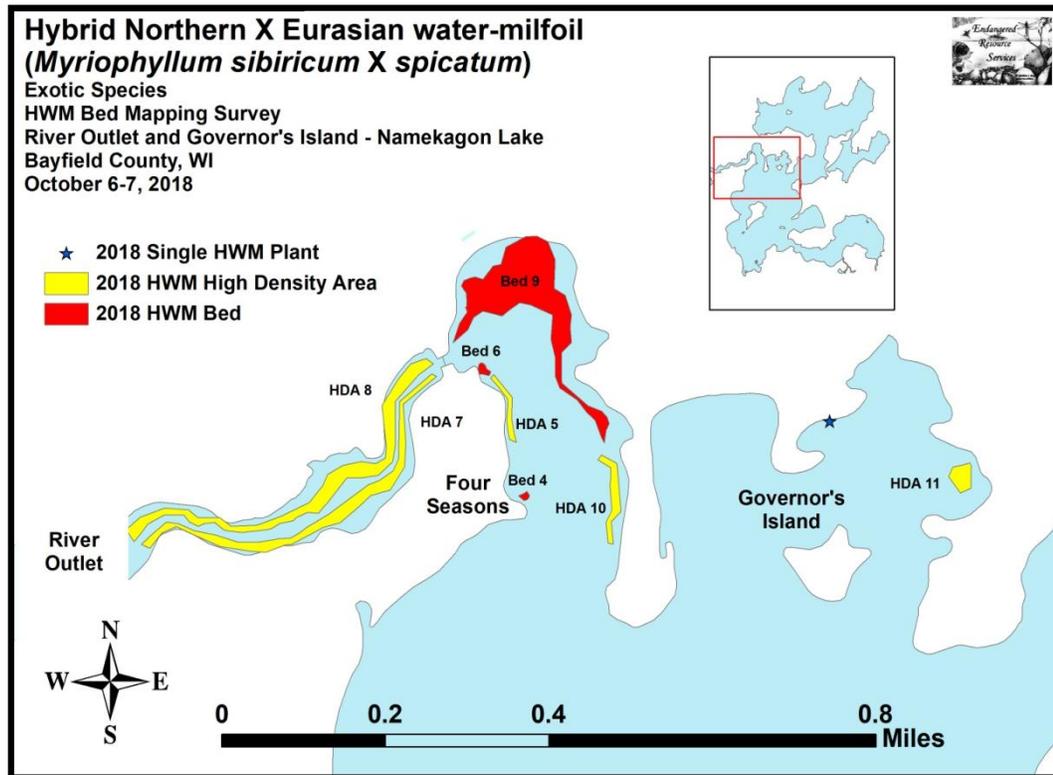
Figure 6: Bed 4-HDA 11 – River Outlet

Bed 4 – Located just beyond the east shoreline docks of the Four Season’s Resort, Bed 4 was little more than a dense collection of towers on the outside edge of a Hardstem bulrush (*Schoenoplectus acutus*) stand (Figure 6) (Appendix I). Collectively, we marked at least 30 different plants mixed in with the greater Northern water-milfoil bed. We also noted that many had been repeated prop-clipped by incoming/outgoing boat traffic.

HDA 5 and Bed 6 – These two small shoreline clusters of plants appeared to be the result of fragments coming from Bed 4. They each had regular clusters, but we found most were single-stemmed suggesting they were relatively recently established.

HDA 7 and 8 – Although we were hired to just survey the lake and couldn't have made it all the way to the dam anyway due to our limited time, we ducked into the lake outlet to see if there were any plants in this area. We quickly discovered that HWM was expanding rapidly on both sides of the river channel. Collectively, we estimated there were 100's of plants in the 1km (0.6 miles) that we surveyed downstream from the bridge. Based on this, we expect that HWM has likely established all the way to the dam.

Bed 9 – This was easily the worst place on the lake as we estimated there were now 1,000's of plants. The bed had continuous well-established towers that were actively fragmenting, and we noted that many areas within the bed were forming a solid canopied mat. Plants were also prop-clipped throughout suggesting it was becoming at least a minor impairment to navigation.

HDA 10 – HDA 10 was simply an extension of the southeastern finger of Bed 9. In this area, HWM was still essentially continuous, but it tended to be much more fragmented with lower densities than in the north bay. This was likely at least partially due to the nutrient-poor sand and gravel substrates that dominated this shoreline.

HDA 11 – There were several dozen HWM plants in the northeast corner of this bay. At its core, the area could have been considered a bed as plants were nearly continuous and canopied; however, the outer edges were extremely fragmented with only scattered plants.

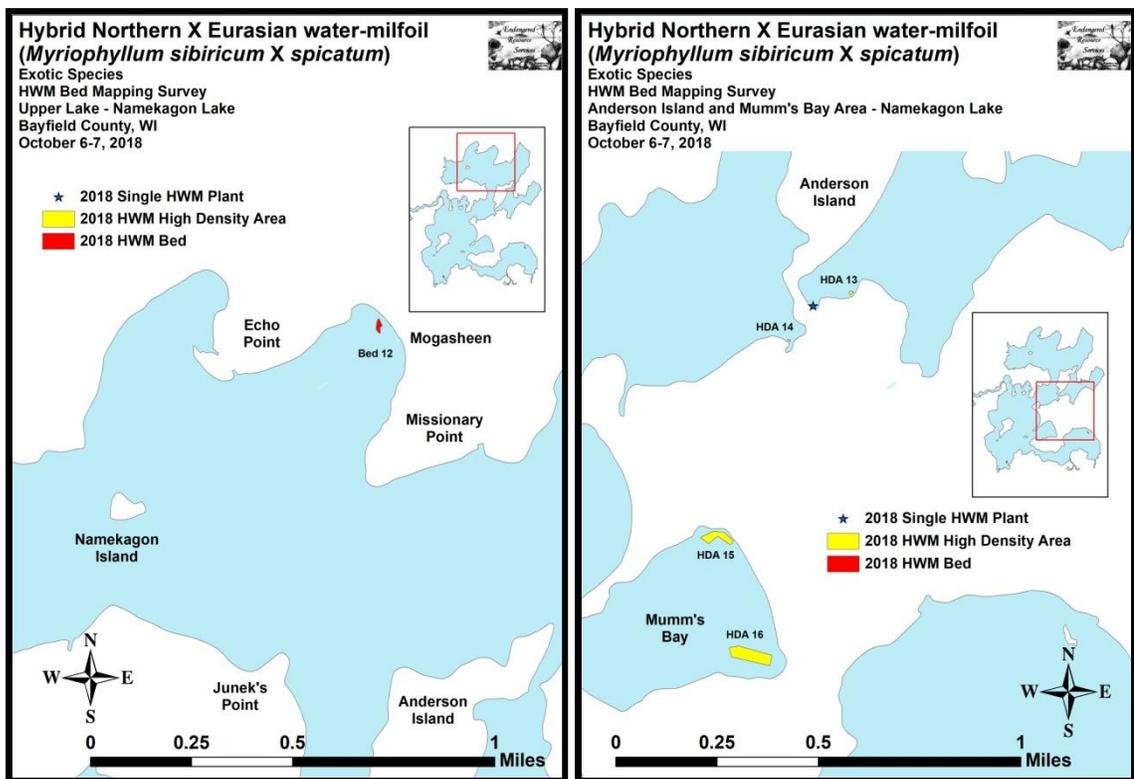
**Figure 7: Bed 12 – Upper Lake/
HDAs 13-16 – Anderson Island and Mumm’s Bay**

HDAs 13 and 14 – These two areas were located along the south shoreline just east and west of the Anderson Island Bridge. Each was little more than a few large multi-stemmed towers, but they were already canopied and actively fragmenting.

HDAs 15 and 16 – Mumm’s Bay had pioneering clusters located on both the northeast and southeast ends of the bay. Although neither area had many total HWM plants, Northern water-milfoil was common throughout the bay suggesting HWM will have ample habitat to expand into.

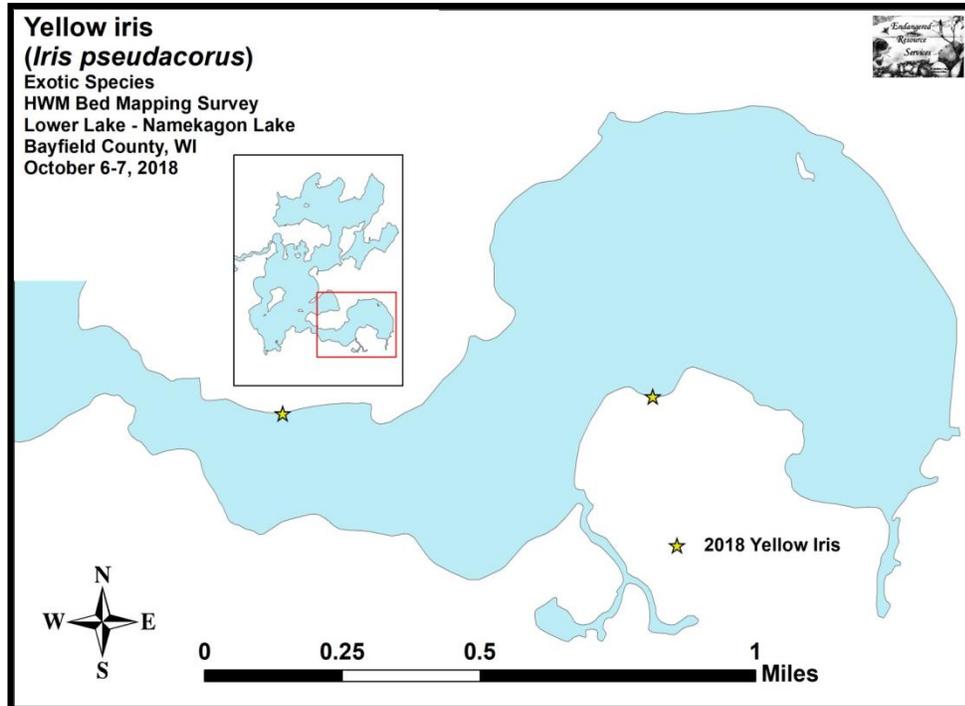
Figure 8: 2018 Yellow Iris Distribution – Lower Lake

We found Yellow iris at two locations in Lower Lake (Figure 8) (Appendix II). Along the north shoreline near the entrance to Middle Lake, two large clusters were present in an undeveloped area of Bergundy Point. Although we pulled all the seed pods off these plants and tried to remove as many of the leaves as possible, we didn't have a shovel and couldn't get the majority of the roots. The other 10+ plants were located on private property along the south shoreline midlake. At this site, residents appeared to be landscaping around the plants as the rest of the vegetation was mowed right down to the lakeshore.

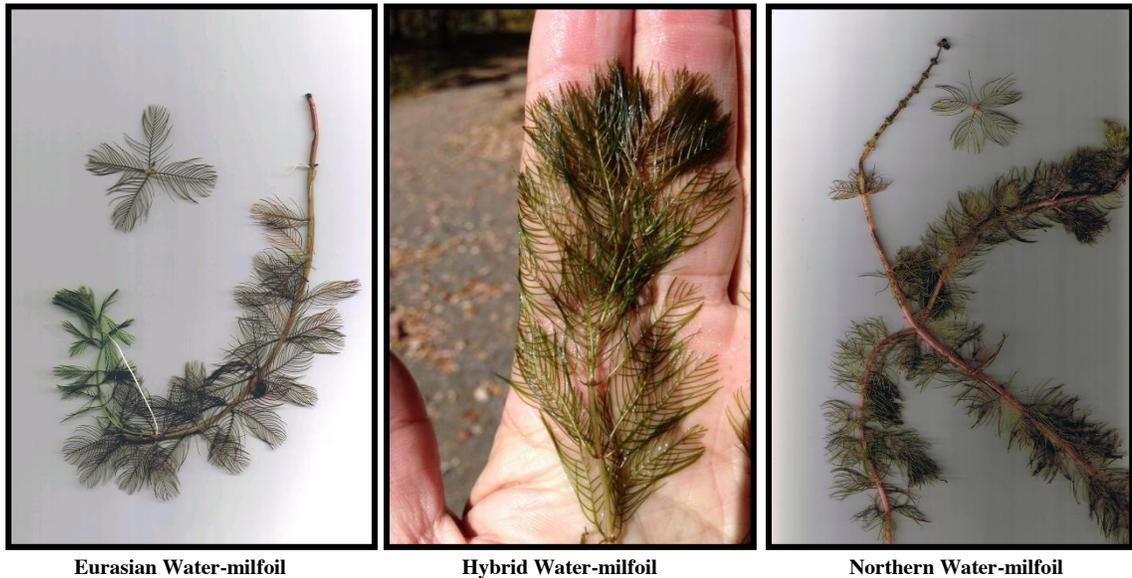
Figure 9: Eurasian, Hybrid, and Northern Water-milfoil Identification

Because native Northern water-milfoil is widely distributed throughout the lake and closely resembles Hybrid water-milfoil, finding and identifying HWM will likely be challenging for volunteers. To assist in identification, surveyors should remember that NWM has leaflets numbering <24 whereas EWM normally has >26 with HWM tending to have leaflet numbers that range from 20-30 – intermittent between both parent species (Figure 9). EWM and HWM also tend to have a bright red growth tip on the top of the plant, whereas NWM has a bright lime-green growth tip. In the fall, NWM also forms winter buds on the tips of shoots whereas EWM/HWM have none (Figure 10).

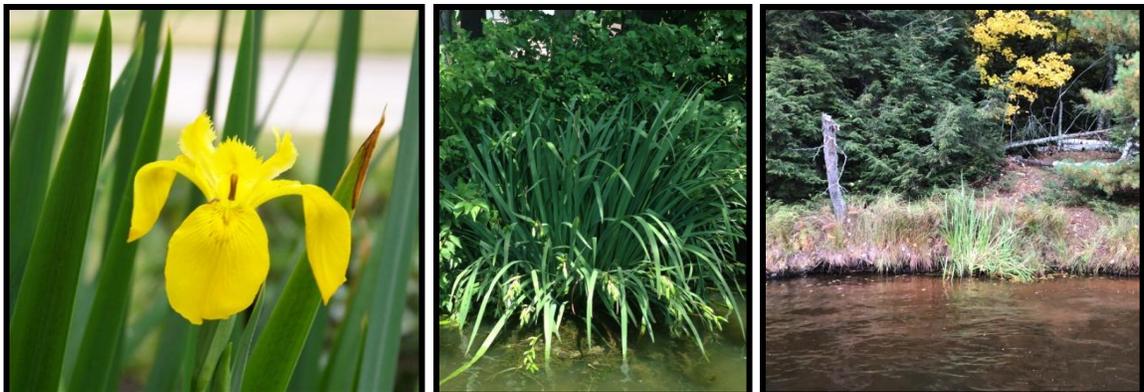
Figure 11: Yellow Iris Bloom, Mature Plant with Seed Pods Hanging in the Water, and an Iris Cluster Seen During the 2018 Fall Survey

The presence of Yellow iris in Namekagon Lake is troubling. Because there are currently no biological control agents for this species, we STRONGLY encourage residents to look for and eliminate plants on their property before a minor problem becomes a significant one. Iris plants and pods should be dug out with a shovel, bagged to prevent seed dispersal, and then disposed of well away from the lake or any other wetland. June is the best month to look for plants as the bright yellow fleur-de-lis are most common and easily seen at this time of year. When not in bloom, Yellow iris can be identified by its tendency to grow in clumps which often have more than 15 total leaves. It also produces abundant seed pods which droop into the water at maturity. In the fall, its leaves remain green well after other plants have been knocked back by frost (Figure 11).
